U.S. ENVIRONMENTAL PROTECTION AGENCY POLLUTION/SITUATION REPORT 2015 Gold King Mine Release SITREP

Subject: Situation Report #10

Gold King Mine Release San Juan County, CO

Date: 08/18/2015

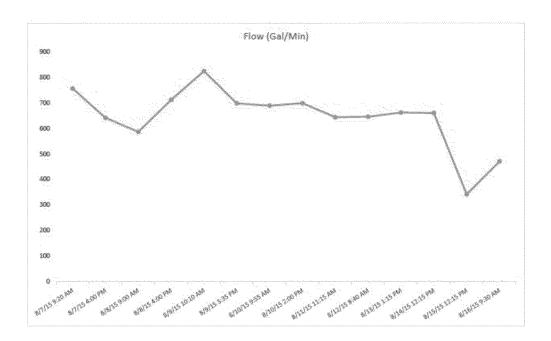
Flow from the mine through the morning of 8/16/2015 is shown in the following chart. **The flow at hour 1500 was 544 gallons per minute (gpm).** Treated water from the last treatment pond is discharging into Cement Creek. **The graph will be updated in the next SITREP.**
